UPPER BALL JOINT FAILURE

2007-2011 GM LIGHT DUTY FULL SIZE PICKUPS AND SUVs

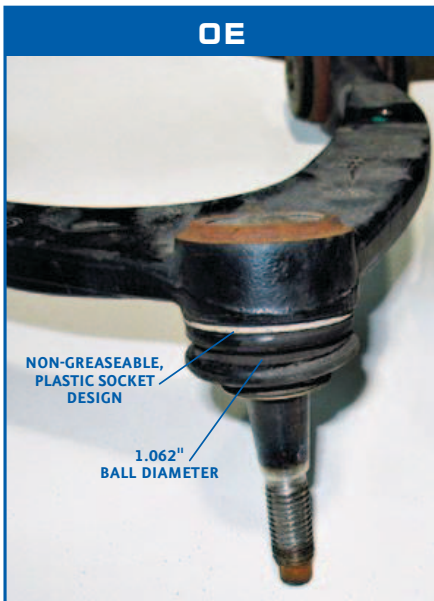
Upper Ball Joint Failure

The OE upper control arm with integral ball joint utilizes a 1.062" ball joint stud and non-greaseable plastic design. This design has been prone to premature failure in as little as 36,000 miles.

MOOG® K80669/K80670 Premium Upper Control Arms

The MOOG® K80669/K80670 control arms feature an integral Problem Solver® ball joint with all-metal design for long life, patented MOOG domed cover plate for minimal axial and radial deflection, and grease fitting for lubrication and serviceability. Its 10% larger ball diameter of 1.180" (.118" larger than OEM) provides a larger ball surface to bearing area to withstand the rigors of light duty truck use. In addition, this long-lasting, one-piece, forged fine-grain steel control arm features preinstalled premium bushings, making it easier to install. Its precision design ensures proper alignment and restores OE ride control.
