Problem Solver Bulletin: 216003

K80996 LOWER BALL JOINT

2005-2015 CHRYSLER/DODGE RWD CARS

LOWER BALL JOINT FAILURE

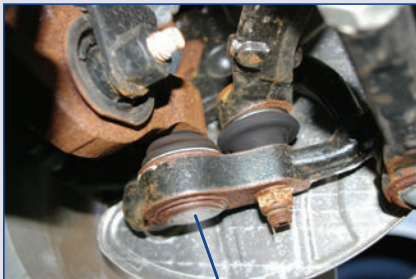
The OE front rearward ball joint in the listed vehicles is a non-serviceable design and prone to failure. Its enclosed polymer socket is unable to flush contamination, which quickly leads to ball stud corrosion and ball socket wear.

OE BALL JOINT
(NON-SERVICEABLE)

The MOOG® K80996 lower ball joint is a greaseable press-in replacement for the OE ball joint. Its superior Problem Solver® design provides long service life and provides a cost-effective alternative to the OE replacement option or replacing the entire knuckle.

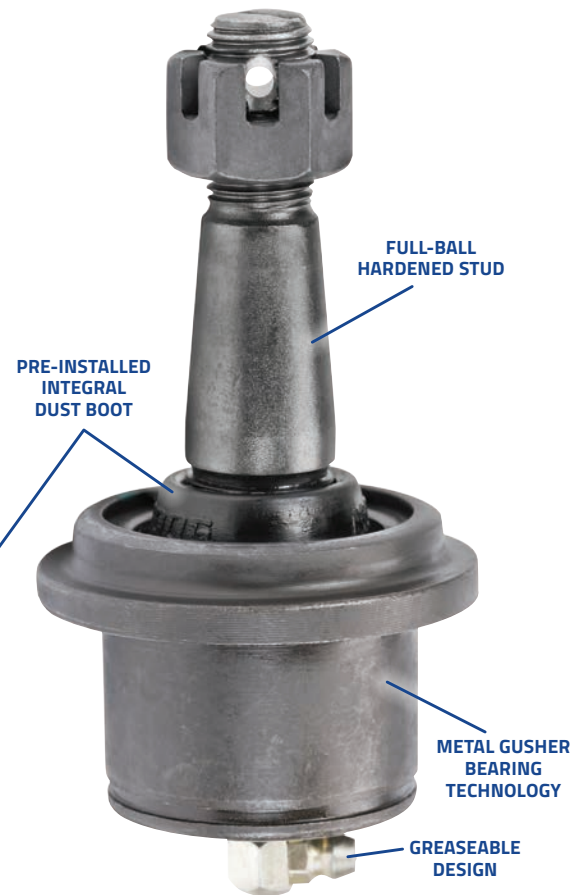
K80996

- Superior design with new, pre-installed integral dust boot for easier installation and longer life.
- MOOG gusher bearing technology for maximum durability and long life.
- Hardened, full-ball stud for smooth and reliable operation over the lifetime of the part.
- Greaseable design that allows lubrication to reach the bearing surface while flushing out contaminants.

Integral dust boot creates a superior seal around stud.
