**MOOG®
STUD MATERIAL**

THE PROBLEM SOLVER®

MOOG® Premium Full-Ball Metal Stud

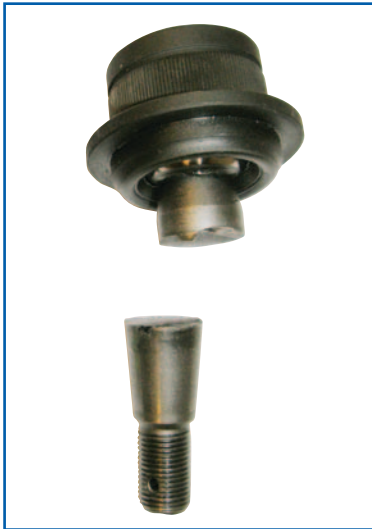
STUD WITH NO INDUCTION HARDENING IS 50% LOWER IN FATIGUE STRENGTH.

- Improper or lack heat-treating can result in cracked/broken studs and steering loss.
- Some suppliers' studs are not induction-hardened, causing them to have 50% or more reduction in fatigue strength.
- Machining the stud end can leave crack-prone stress risers that may lead to stud fracture.

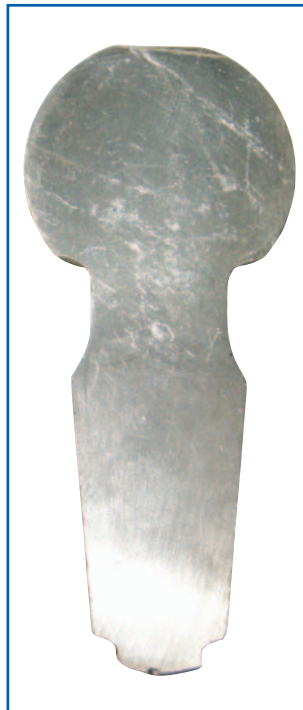
ALTERNATE SUPPLIER'S STUD, CRACKED DUE TO IMPROPER HEAT-TREATING

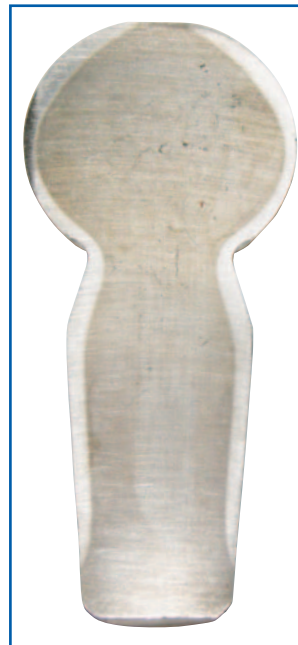
HEAT-TREAT INDUCTION HARDENING CREATES A WEAR RESISTANT SURFACE ON THE BALL AND INCREASES THE FATIGUE STRENGTH OF THE STUD.

MOOG studs are engineered with a hardened exterior and a soft core, which allows them to bend instead of break during a severe impact. This prevents the complete loss of steering that would occur if the stud actually broke. In addition, through complete understanding of the OEM material and heat-treat, MOOG designs a stud to meet or exceed the OEM stud's strength.

- Consistent-dimension forged alloy steel construction that eliminates taper-end machining.
- MOOG-specified steel composition that produces stronger consistency than commonly used larger-grain composition.
- MOOG ball construction that offers excellent core ductility with a hard, heat-treated outer shell.

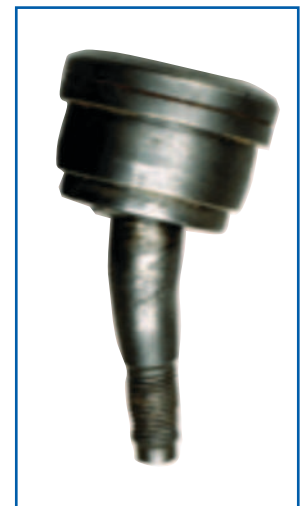
MOOG STUDS ARE DESIGNED TO BEND, NOT BREAK, IN CASE OF SEVERE IMPACT.
