NON-SOCKET STYLE SWAY BAR LINK KIT

THE PROBLEM SOLVER®

VARIOUS VEHICLES

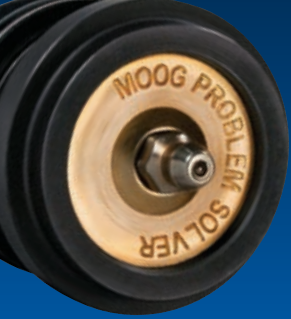
Traditional Non-Socket Style Sway Bar Links

The sway bar link on the affected vehicles comes in many styles. Other suppliers may utilize a small-diameter bolt. This small size makes the bolt susceptible to the damaging effects of road shock and corrosion. In addition, the neoprene bushings used in many of these links do not stand up well to stress and weather conditions. Also, other suppliers may use a rolled steel sleeve which can allow contaminants in, leading to corrosion and failure.

NOTE BROKEN SWAY BAR LINK

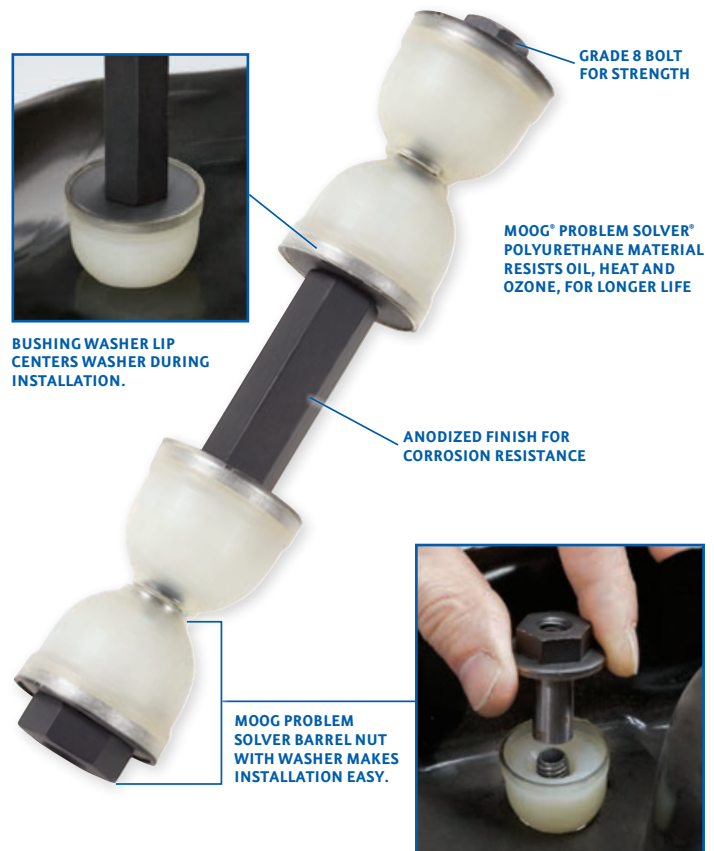
SWAY BAR LINK KIT - BOLT AND BUSHING

MOOG® Problem Solver® Sway Bar Link Kit

- MOOG® Problem Solver® design includes polyurethane bushings for enhanced durability and performance.
- Barrel nut provides proper thread engagement for easier installation.
- Nested washers help keep bushings centered during installation.
- Solid black anodized T6 aluminum hex spacer provides superior corrosion protection and provides easier removal.
- Black oxide 3/8" Grade 8 bolt provides strength and corrosion protection
