OFFICIAL STEERING & SUSPENSION OF NASCAR®

THE PROBLEM SOLVER®

Lower control arm failure due to corrosion

MOOG® Problem Solver® CK641180 lower control arm (rear)

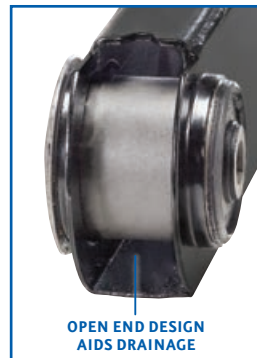
OPEN END DESIGN AIDS DRAINAGE

SWAY BAR BOLTS DIRECTLY TO PART

The MOOG® Problem Solver® CK641180 lower rear control arm is more rugged than the OE design. Its larger box construction provides additional strength and durability. The CK641180 is open on both ends to keep water from becoming trapped in the part, to help eliminate corrosion. In addition, the sway bar bolts directly onto the control arm, preventing issues that a welded bracket can cause.
